Impact of Residual Quartz on Lifetime of High Strength Porcelains

Markku Ruokanen, PPC Austria Holding GmbH, Marek Vrabc, PPC Insulators Ćab
Anton TRNÍK, Omar AL-SHANTIR, Dominic MIKUŠOVÁ,
Constantine the Philosopher University in Nitra, Slovakia

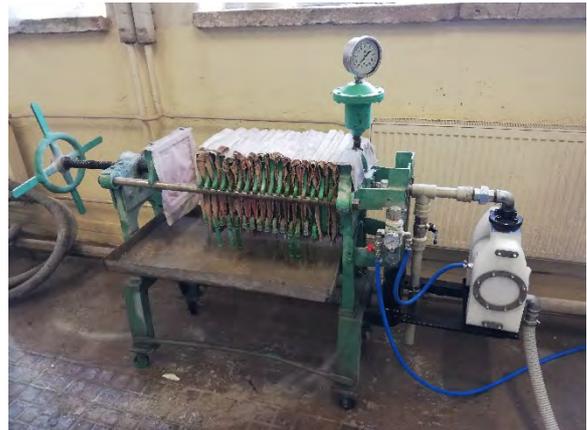
Fig 1. The laboratory filter-press

The quartz particles were mixed into the base-body in the wet laboratory mill by 1 wt.%, 2 wt. % and 4 wt.%. Test-bars with 0 wt.% added quartz were made of the same batch of body to get the baseline. The body was pressed in the laboratory (Fig. 1) and extruded with the laboratory extruder (Fig. 2) to a 10 mm diameter and 150 mm long test-bars.

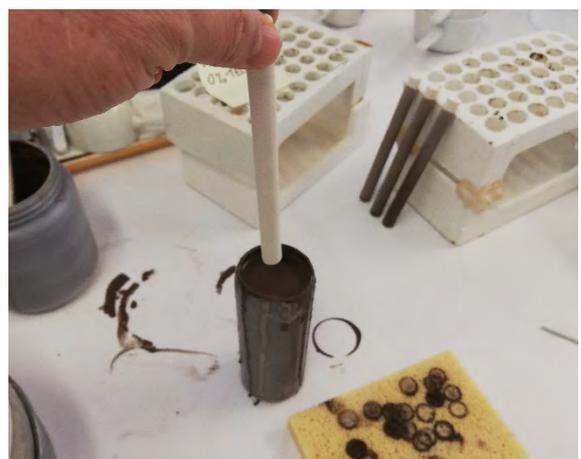
Fig 3. Manual Glazing

After drying the bars were manually glazed by dipping (Fig. 3). After glazing the samples were fired in the normal production kiln (Fig. 4). On the Figure 5 we see a ready fired Test bar.

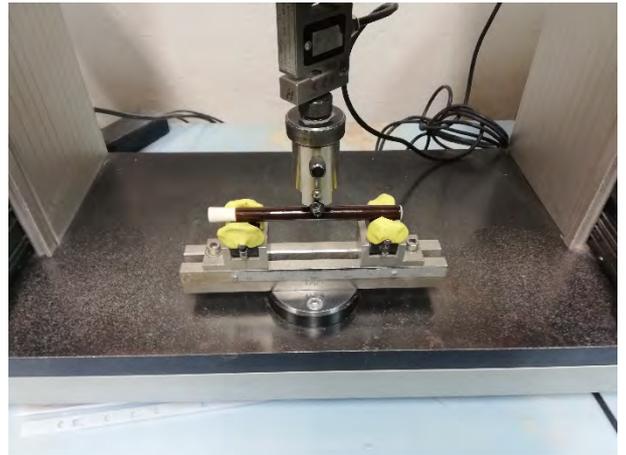
Fig 6. 3-point bending machine.

The 3 point-bending machine (Fig. 6) was used to break and submit the samples under cyclic loading. The sampling size of each test was defined as 10 pieces. First the base-strength was tested at 3-point bending machine, then new samples were cycled with 50 % of the measured breakage strength and after cycling they were loaded to breakage. As there was no references of how many cycles the bars could support it was decided to start with 100 and 500 cycles. (Fig. 7)

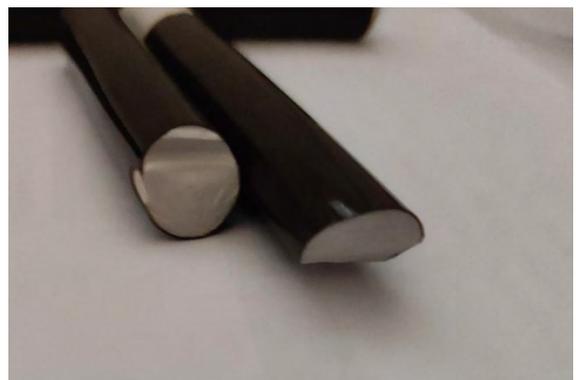
Fig 8. Broken test bar at 3-point bending test.

After the breakage the test-bars were inspected to be sure that the breakage was not caused by an external defect on the glazing or impurities on the body.

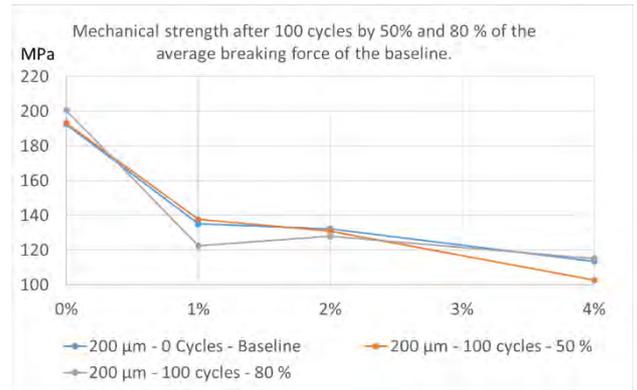
Fig. 9: Mechanical strength after 100 cycles by 50% and 80 % of the average breaking force of the baseline.

We can see from the figure 9, that there is not significantly difference between graphs. The conclusion was that the quantity of cycles was too low to cause measurable crack-growth. Then the similitude of the curves with high Weibull modulus is a clear indication that there was only one failure mode at the breakage. This means the base material was homogenous, which allows the elimination of failures caused by impurities or non-homogeneous structure. Therefore, when there is a measurable difference, it would be caused only by the added quartz particles.

On the figure 9 we can see the results of the first two cycling series.

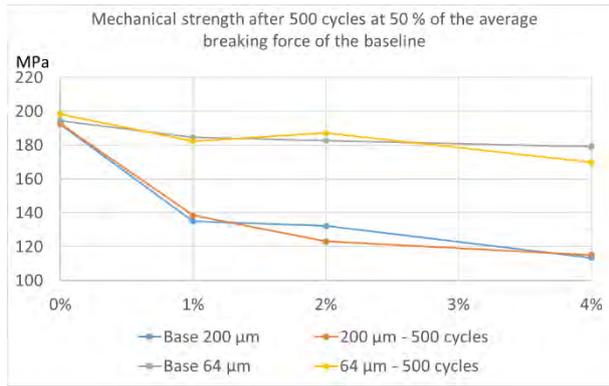
Fig. 10: Mechanical strength after 500 cycles at 50% of the average base-line breaking force.

The increased cycling was not enough to cause measurable crack-growth with the applied force.

The cycling was increased to 500 cycles. The results are on the figure 10.

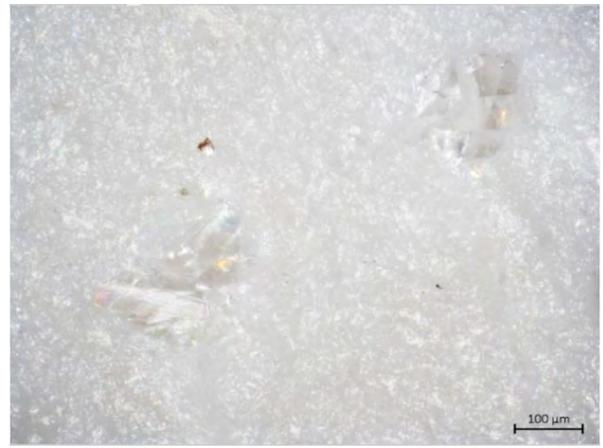
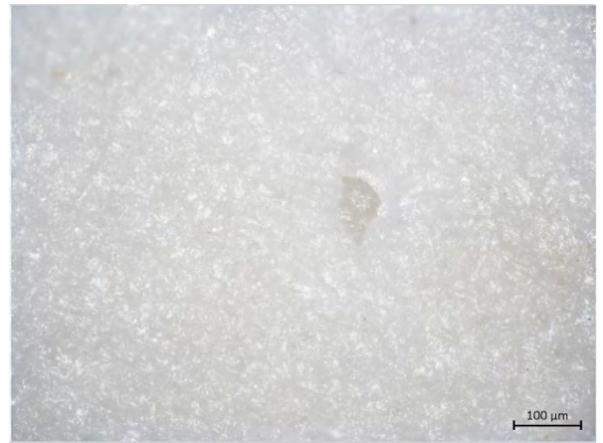
The breakage surface was observed by a light microscope. The quartz grains were easy to identify on an otherwise smooth surface.

Fig 11: two 200 μm quartz crystals on

Fig.12: one 64 μm quartz crystals on breakage surface breakage surface.

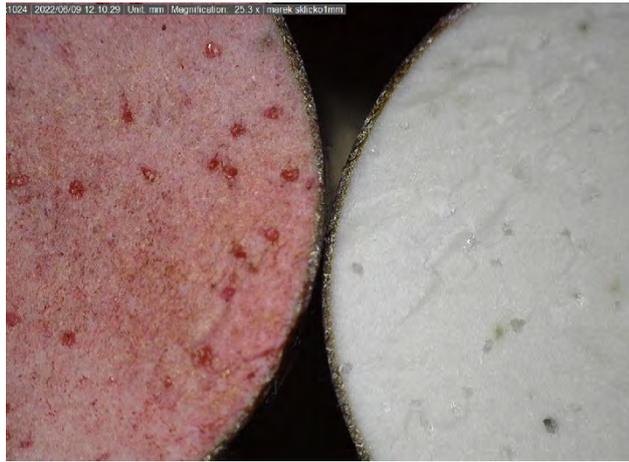
A dye penetration test was executed to reveal the potential cracks on the breakage surface.

Fig.13: Breakage surface after 30'000 cycles. The dye penetration test reveals the quartz particles clearly as the liquid penetrates the microcracks of the crystal. Anyhow there is no visible crack propagation on the base material.

The sample did not break during the cycling. After 30'000 cycles the mechanical breaking force was same level then it was at after 100 and 500 cycles.

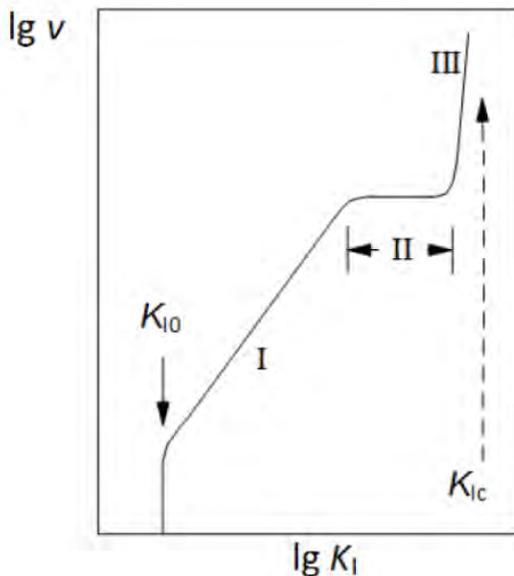
With the use of stress intensity factors K_I the principal course of the sub-critical crack growth can be visualised by drawing the crack growth speed as function K_I in double logarithmic diagram, see Fig. 14.

Fig.14: Schematic sub- critical crack growth development.

In most cases K_I must pass a threshold K_{I0} to initiate crack growth, in the region I the crack speed obeys exponential equation, in the cases

where region II exist, a constant crack speed can be observed. Finally in the region III the transition to super- critical crack growth and complete failure occurs. In the case of ceramics regions II and III takes only a negligible time, so region I is relevant for the lifetime prediction.
