# Porcelain Insulators and Covered Conductors – A Problem of Dielectric Compatibility

#### Eduardo Riani Hilsdorf – 1 Manuel Luis Barreira Martinez – 2

#### ABSTRACT

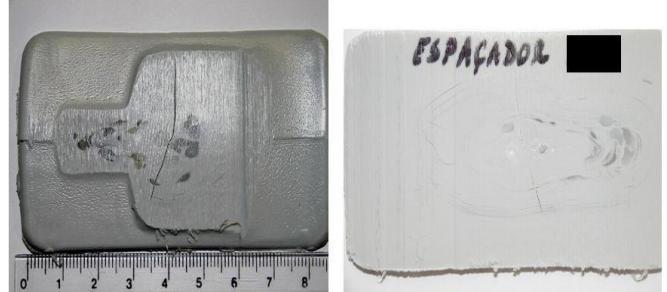
Figure 1 – Photo of sections in polymerical spacers exhibiting nonuniform material.

- Partial internal discharge due to the heterogeneity of material used, in the polymeric spacers - Figures 1 - 3;

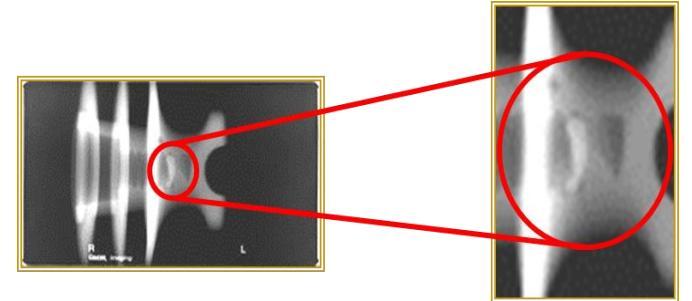
Figure 2 – Electronic radiography of insulator containing internal air bubbles coming from the manufacturing process

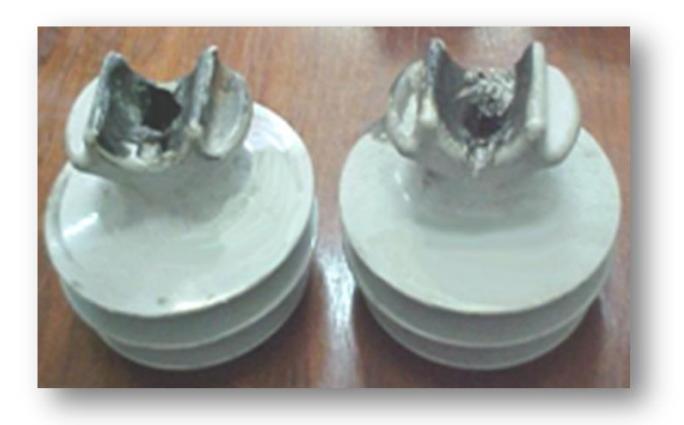
Figure 3 - Photos of insulators including internal defects, which degradated in operation a time after their installation in network.

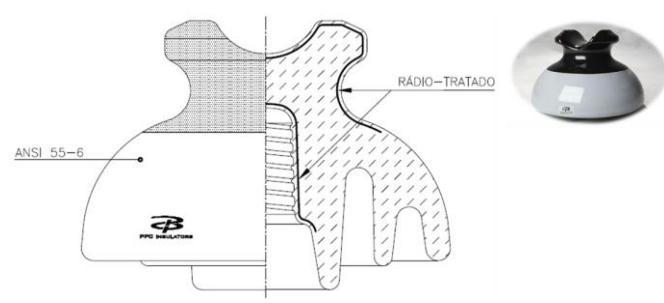
Figure 4 - Radio - Free Treated

Figure 4 indicates the radio-free treatment applied to insulators in conformity to ANSI Class 55-6 of C29.5 Standard.

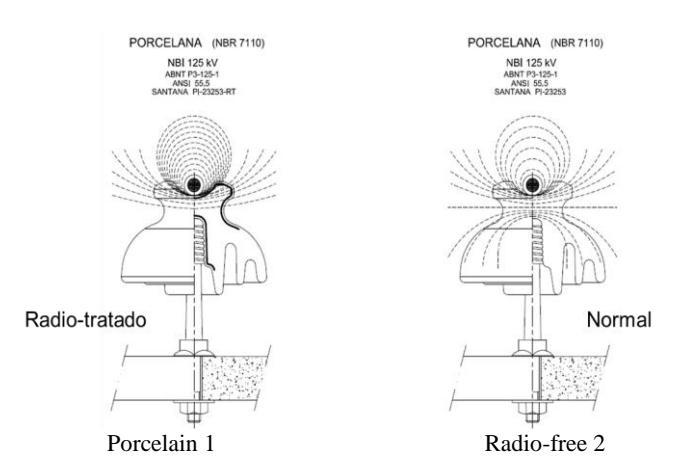
Figure 5 – Illustration of radio-free treatment effects on electrical field lines in ANSI 55-6 Class insulator.

Application of these insulators in compact networks with covered conductors, however, has brought an increase of equipotential line concentration in conductor insulating area, since the reduction of field lines crossing porcelain in radio-free treated insulator caused a concentration in conductor insulation. Figure 5 shows this effect.

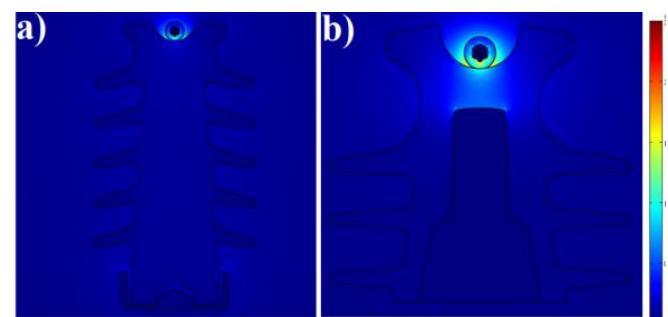
Figure 6: a) Ceramic line post insulator  $P_1$ , b) Polymeric pin type insulator.

In Figures 6 "a" and "b" shows the modeling results for line post ceramic insulator and pin type polymeric insulator, respectively.

In Figure 6b electrical field concentration is the result of the proximity of grounded pin related to energized conductor. In dielectric terms these stresses are critical mainly for steep impulses. The pin presence also acts in the sense of transferring stresses into cable insulation, as it can be seen through color concentration.

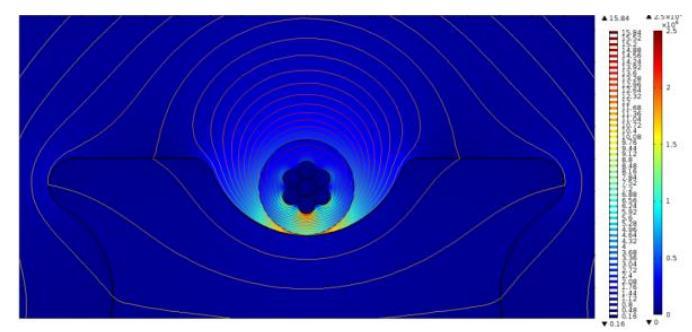
Figure 7 - Study of electrical field around post type ceramic insulator  $P_1$  - RT radio-free.

Finally, comparing the number and shape of the equipotential lines on Figures 7 and 8, it is noticed that, without the presence of semi-conducting glaze, there is a greater number of field lines crossing porcelain and consequently a lower potential concentration on the region of the insulation of the covered conductor, resulting in a lower dielectric stress. The relation between gradients  $E_2$  – Gradient of the electric field in the interface between the external surface of conductor insulating layer and the insulator and  $E_1$  – Gradient of electrical field in the interface between conductor surface and the polymer insulating layer of the covered conductor, for both studied insulators, is 1.40 & 1.18 respectively. This indicates, numerically, the heavy

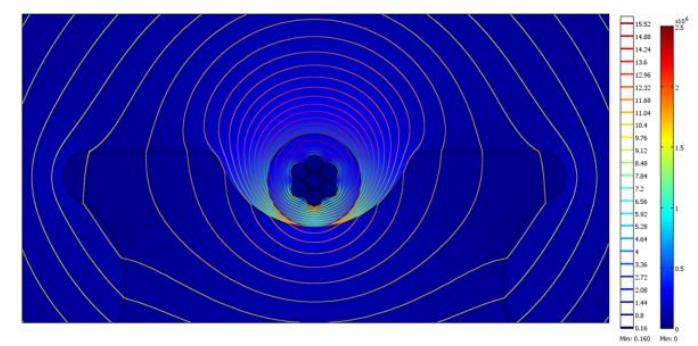
Figure 8 – Study of electrical field on  $P_1$  ceramic insulator line post type without radio-treatment

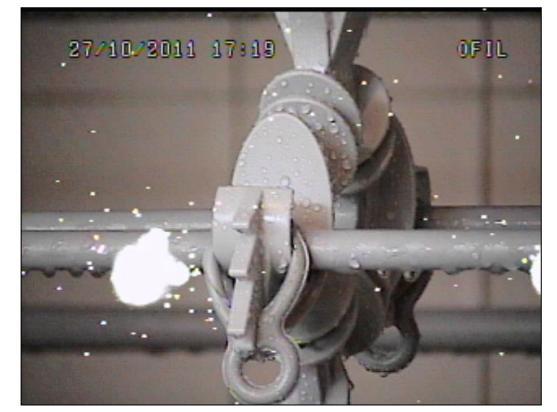
Figure 9 – Formation of discharges along covered conductors manufactured in Brazil, during compatibility tests on polymeric spacers [9].

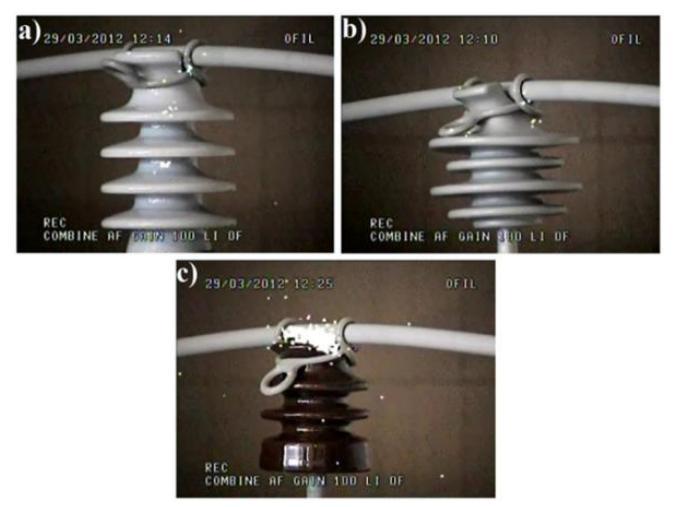
Figure 10 - Image of corona effect on insulators designed for 15kV voltage class – a) Ceramic insulator solid core line post type, b) Polymeric insulator pin type, c) Ceramic insulator pin type.

Figure 10 shows results for the three types of insulator, installed with covered conductor and tied with an elastic ring where, as in Figure 9, the white dots on the image represent the electrical activity for each case. The analysis of these results is qualitative, through comparison, since methods working with image detection of external partial discharges have not up to now the capacity of associating measured values to operation conditions.

The analysis of the results indicates a strong development of discharges in the interface between the covered conductor and the groove of the pin type ceramic insulator. This is a strong indication that pin type ceramic insulators shall not be used in compact networks, under the risk of causing at medium and long term external partial discharges, capable of compromising the system performance, at best by reducing the dielectric withstanding of the insulators, with the loss of any benefit associated to the better insulating coordination offered by compact systems.

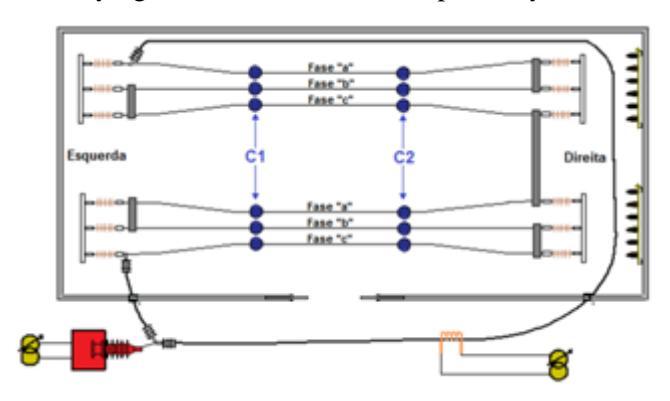
Figure 11 – Basic installation diagram for the test of multi-stress electrical compatibility in conformity to LAT-EFEI.

Figure 11 exhibits the basic diagram of test set up at the LAT-EFEI – Itajubá Laboratory of High Voltage for carrying out the multi-stress compatibility test.

An induction system allows the circulation of current, responsible for keeping cable temperature at 60°C. A voltage source regulates voltage level applied between phase and ground equal to  $2U_0$  with water conductivity constant monitoring. A daily visual inspection and checking of the rain control was carried out, also observing the regulation of the remainder parameters.

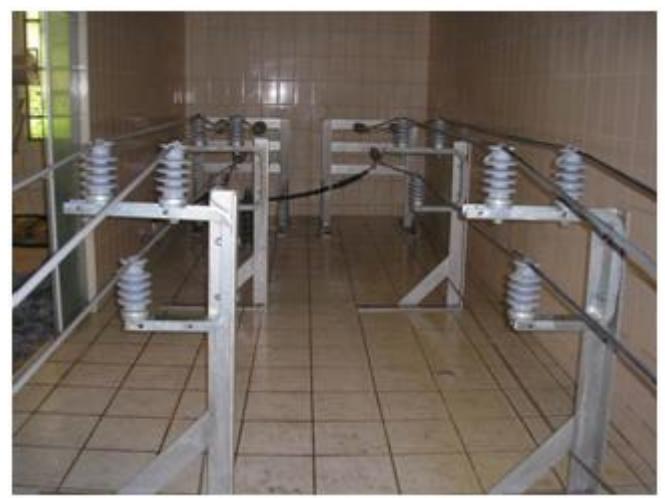
Figure 12 - Images of the starting of the dielectric compatibility test on 3 line post ceramic insulators, 15 kV voltage class, P<sub>2</sub> reference, carried out on September 16<sup>th</sup> 2011.

Figure 12 exhibits photos of test carried out on post type porcelain insulators solid core. It also shows two of the arrangements tested with two cables of different manufacturing, one of gray color at left and the other of black color at right.

This difference of colors represents differences in manufacturing. In this specific case, cable at left was manufactured with two layers, one internal, next to conductor, with semi-conducting characteristics, and the second, external, in standard XLPE framework.

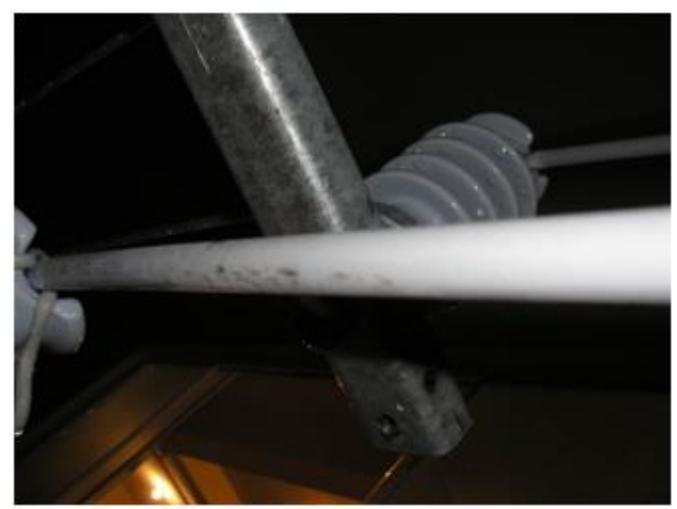
Figure 13 – Image of the dielectric compatibility test on line post type ceramic insulator, 15 kV voltage class,  $P_2$  reference, phase "b", on September 16<sup>th</sup> 2011 + 5 days.

After 5 days of test, for the cable with semiconducting layer, in accordance with Figure 13, signals of erosion were already observed at phase "b", in midspan, out of simulated critical zone, that is, in the interface zone between cable and insulator. That is an extremely alarming point, because these signals appear in a place not foreseen or explainable through any electrical field simulation.

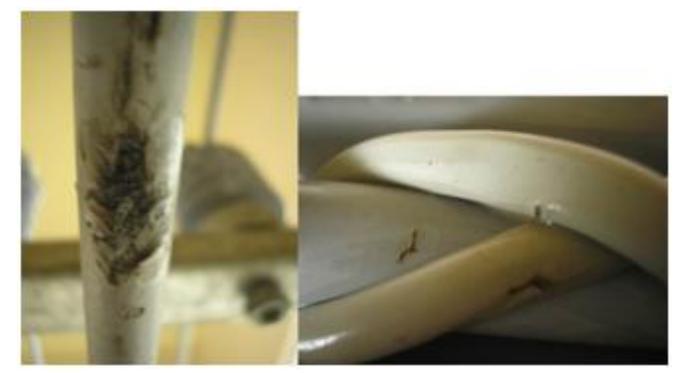
Figure 14 – Images of the dielectric compatibility test on line post type ceramic insulator, 15kV voltage class,  $P_2$  reference, phase "b" (Left) and "a" (Right on September 16th 2011 + 6 days.

Figure 14 shows the evolution of problem as noticed, after one day - the 6th. The observed damages are strong indicators that the system has no capacity of withstanding combined stresses of voltage, current and temperature, under the accelerated condition formation of superficial partial discharges, that are responsible for the acceleration mechanisms of natural ageing of the system cable – insulator. This process has a trend to accelerate and take the system to a complete failure.

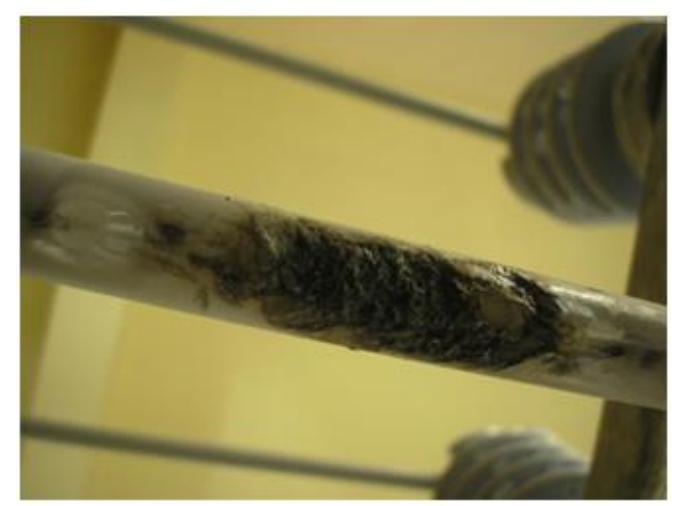
Figure 15 - Image of the dielectric compatibility test on line post type ceramic insulator, 15 kV voltage class, P<sub>2</sub> reference, phase "b" on September  $16^{\text{th}} 2011 + 10 \text{ days}$ .

Figure 15 exhibits results on insulators withdrawn after 10 days of testing, when system can be considered as degraded and in the imminence of failure, in a region out of the insulator groove, what is not expected, indicating a deficiency of cable insulation on those points.

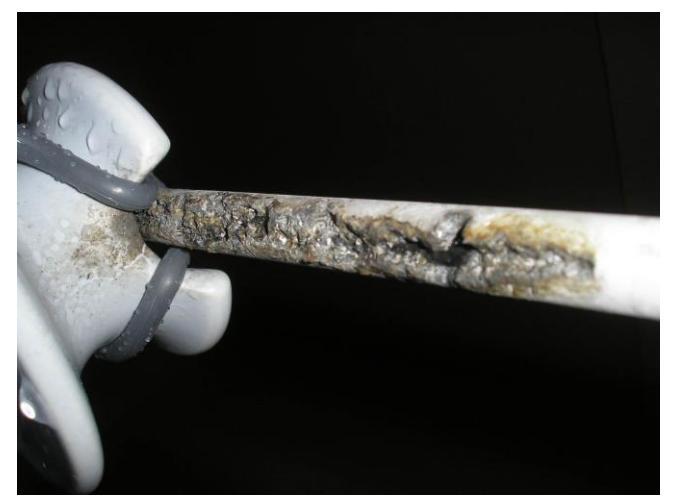
Figure 16 - Image of dielectric compatibility test on line post type ceramic insulator, 15kV voltage class, reference P<sub>2</sub>, phase "b", on September  $16^{th} 2011 + 25$  days.

Figure 16 exhibits the failure evolution "towards insulator".

Failure starts in a point along the cable. The proximity of a grounded point, in this case provided by insulator (grounded support) makes leak current between energized cable and ground flow through external surface of cable toward insulator.

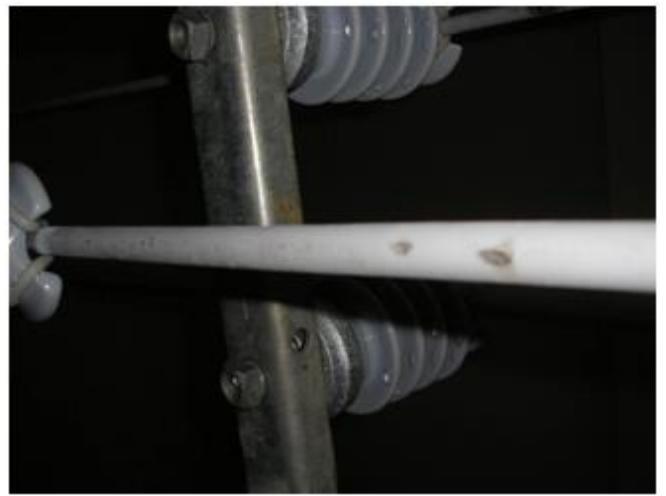
Figure 17 – Image of dielectric compatibility test on ceramic line post insulator, 15kV voltage class,  $P_2$  reference, phase "b", on September  $16^{th} 2011 + 25$  days.

The superficial conductive carbonized region and tracks developed during this process, sets out towards the insulator groove, that in the end appears damaged and in for someone converted into a possible source of failure, as in the photo. As shown in the photo sequence, however, the insulator was not responsible for the starting of the failure phenomenon, and for that reason, an active role is not attributed to it. This can be also confirmed analyzing Figure 17, where carbonized dots, in middle-span, are observed far away from insulators. In these cases, the distance from the grounded point, the lack of uniformity of cable insulation and artificial rain, manage to control the current paths towards the grounded points that present higher impedances than those in close zones, reducing the amplitude of superficial current along the cable and, consequently, the observed damages.

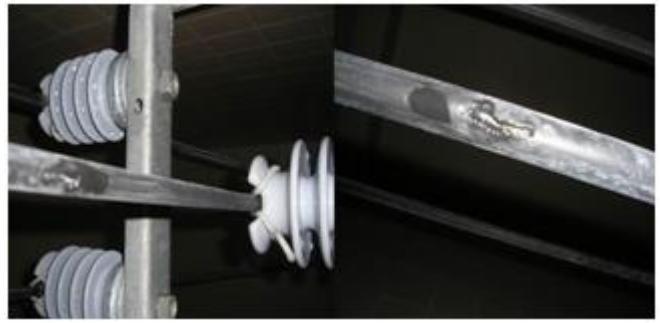
Figure 18 – Image of the dielectric compatibility test on ceramic line post insulator, 15kV voltage class, P<sub>2</sub> reference, phase "b", black cable, carried out on  $16^{th}$  September 2011 + 25 days.

Figure 18 exhibits results of the tests on the cables of black color, manufactured without the semiconducting layer next to conductor. In this case a failure is visible in middle - span, related to porcelain insulator and in detail to metallic core of cable.

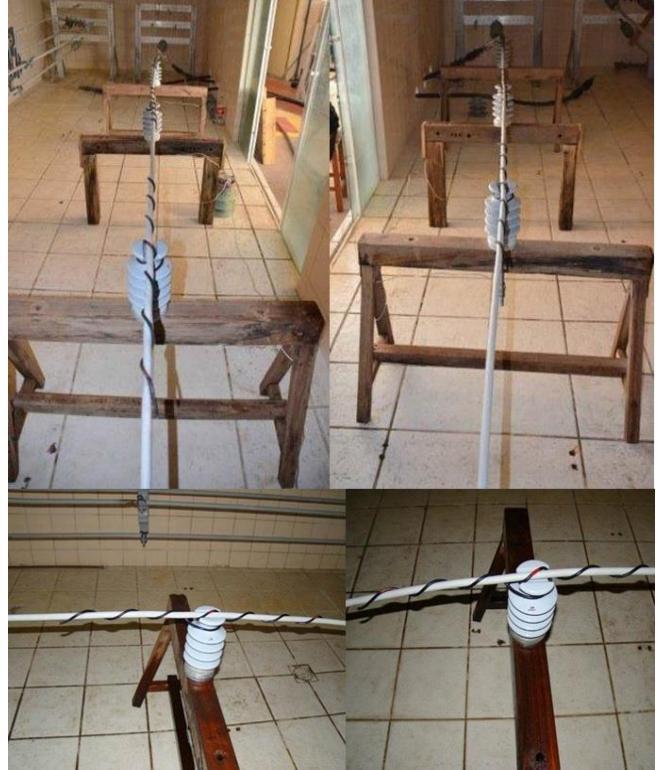
Figure 19 – Image of start of dielectrical compatibility test with 3 insulators ceramic post type, 15kV class voltage, P<sub>2</sub> reference, carried out in October 2012.

During the test and at the test end, no damage, tracking or erosion were observed on interface region between cable and insulators, as can be verified in the images on Figures 19 and 20. Therefore, the test set up withstood the combined stresses, as claimed by the standards.

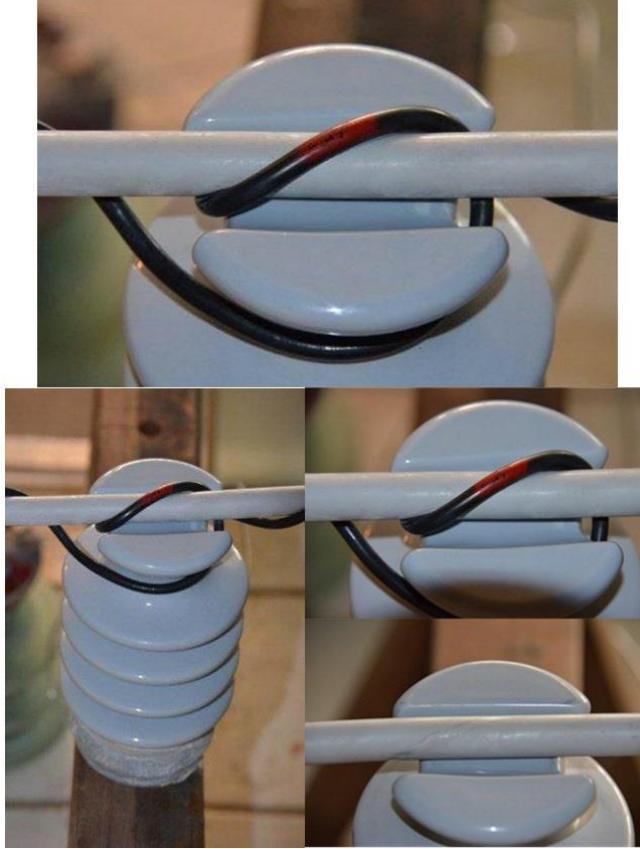
Figure 20 - Image of the end of dielectrical compatibility test on 3 ceramic insulators post type, 15kV class voltage, P<sub>2</sub> reference carried out in October 2012.

Images indicate that no marking was observed on the cables, except salt deposition as a remainder of rain with conductivity corrected to 750  $\mu$ S/cm, staying with the same appearance at test start.
